# BEARING FATIGUE INVESTIGATION

E.N. Bamberger

FINAL REPORT

CONTRACT NAS 3-7261

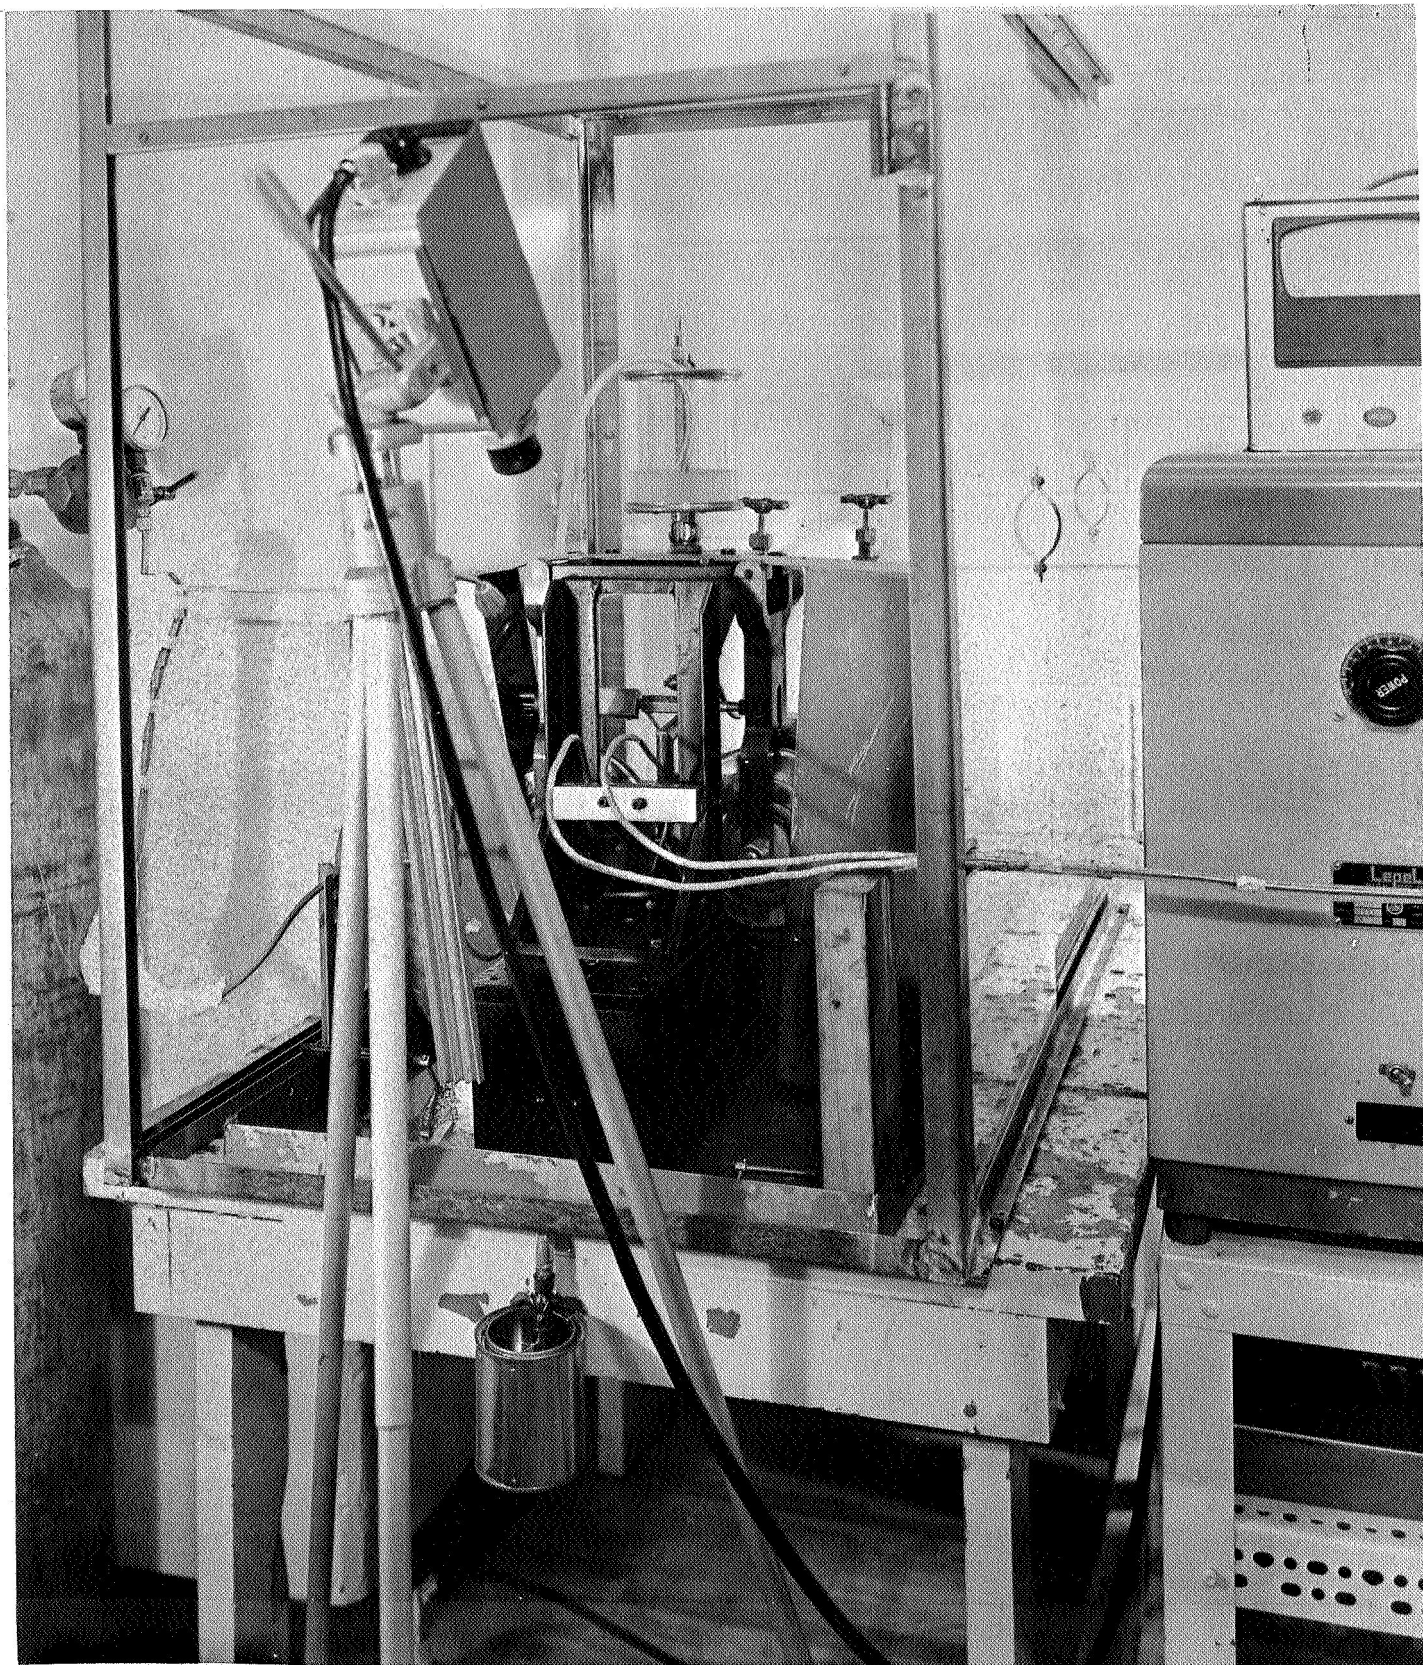
FIGURE 7. INFRARED PYROMETER IN **USE** ON RC RIG

In the current program, the test bars were heated via a high frequency induction coil wrapped around the test bar both fore and aft of the contacting rollers. An "Ircon" Infra-red Pyrometer trained on the contact area measures and controls the temperature. Exact temperature control is achieved by using a pyrometer controlled saturable reactor control to cycle the induction heater, Figure 7 shows a view of the Pyrometer Control set-up and a close-up of the induction coil is shown in Figure 8,

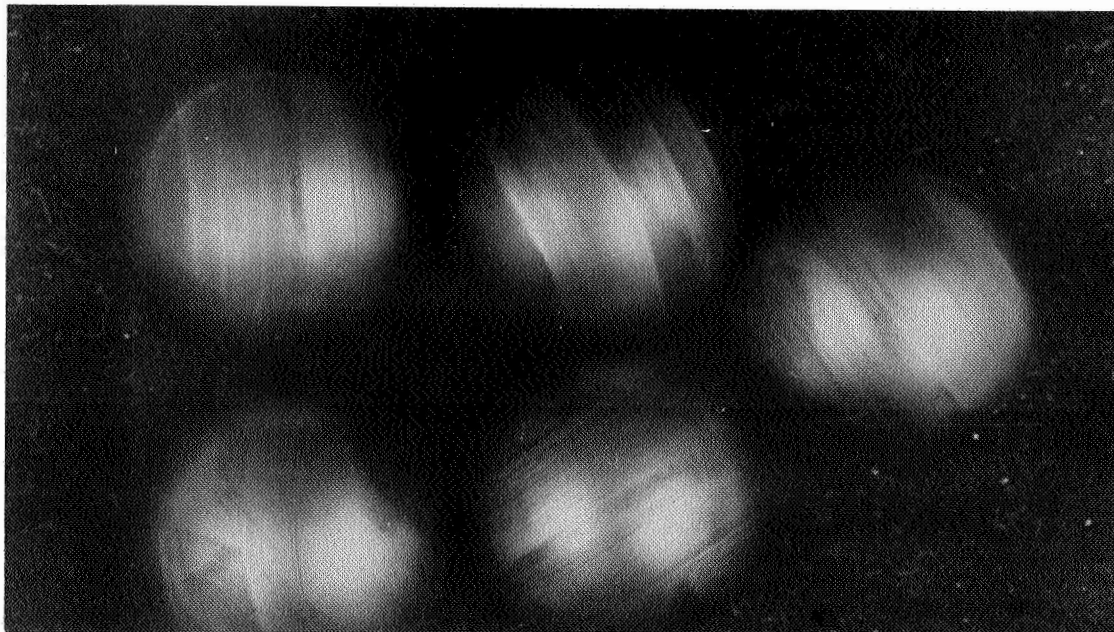
FIGURE 39. BALLS FROM BEARING S/N 10

RUNNING TIME:	500 HOURS
LUBRICANT:	XRM-177F
TEMPERATURE:	600F
LOAD:	5800 LB. AXIAL
SPEED:	12,000 RPM (INNER)

A number of bearings achieved 500 hours. One of these was Bearing #10 and Figure 39 shows several balls from this bearing,. The outer ring ball track of the same bearing is shown in Figure 40.

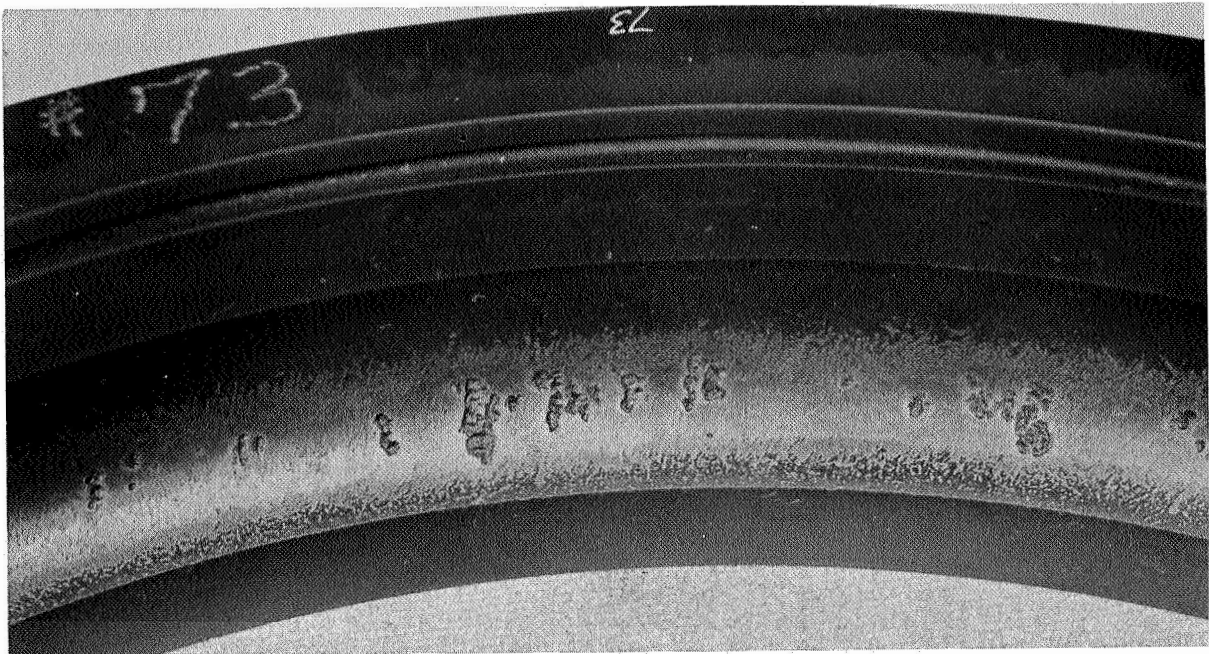
FIGURE 84. BEARING S/N 73. FATIGUE FAILURE ON INNER RING.

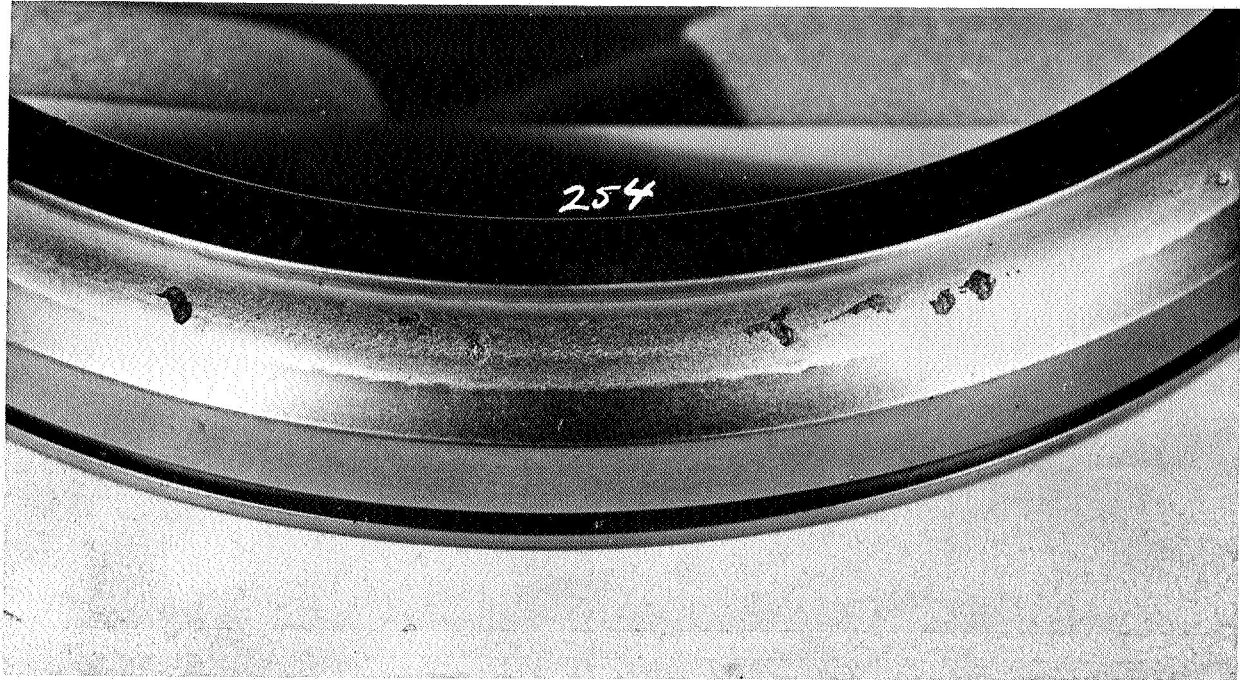
FIGURE 99. TOP: INNER RING FATIGUE FAILURE, S/N 254  
 BOTTOM: BALLS FROM S/N 254

BEARING MATERIAL:	WB-49 RINGS
	M-1 BALLS
LUBRICANT:	XRM-177F
LOAD:	5800 LB. AXIAL
<b>SPEED:</b>	12,000 RPM
TEMPERATURE:	600F (METAL)
TIME TO FAILURE:	26 HOURS

The failures encountered were with one exception, normal sub-surface initiated fatigue failures. Figures 99 through 108 are photographs of typical WB-49 bearing components failed in fatigue. The only deviation from these failures was in bearing S/N 272, where a circumferential outer ring fracture was observed. Generally, the balls made out of M-1 material appear to be relatively undamaged despite the rather severe fatigue failures observed on other components. This is illustrated in the bottom of Figure 99. While there have been a number of ball fatigue failures, it is difficult to establish whether these failures are unique **or** are caused by a prior failure of the inner **or** outer ring. As may be noted in Table 15 the ball

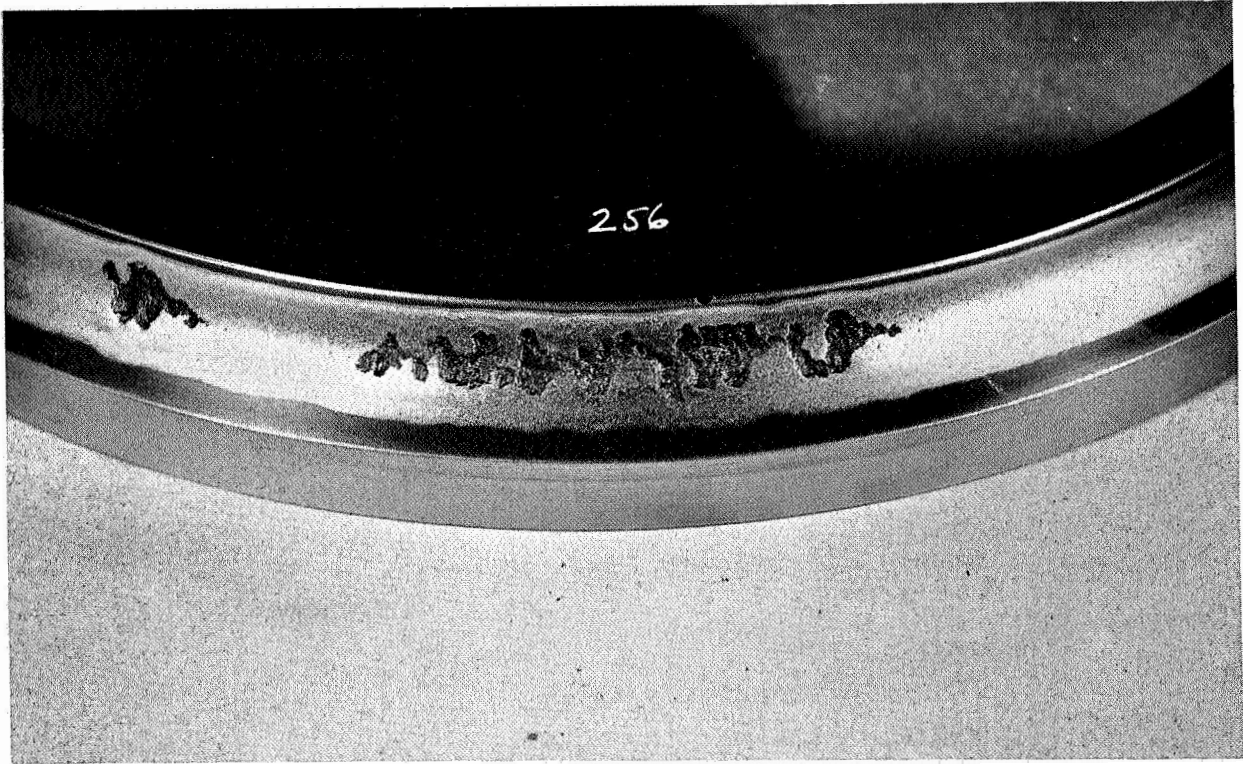
FIGURE 101. INNER RING FATIGUE FAILURE, S/N 256

BEARING MATERIAL:	WB-49 RINGS
	M-1 BALLS
LUBRICANT:	<b>XRM-177F</b>
LOAD :	5800 LB. AXIAL
SPEED:	<b>12,000 RPM</b>
TEMPERATURE:	600F (METAL)
TIME TO FAILURE:	26 HOURS

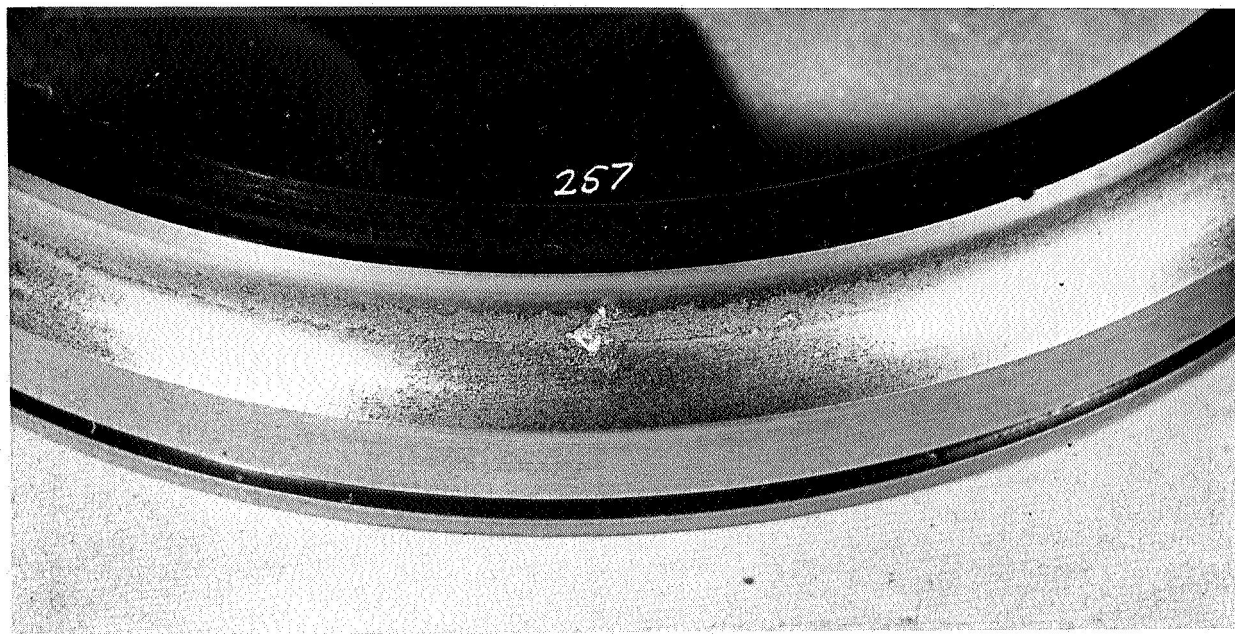
FIGURE 102. INNER AND OUTER RING FATIGUE FAILURES, S/N 257

BEARING MATERIAL:	WB-49 RINGS M-1 BALLS
LUBRICANT:	XRM-177F
LOAD:	5800 LB. AXIAL
SPEED:	12,000 RPM
TEMPERATURE:	600F (METAL)
TIME TO FAILURE:	24 HOURS

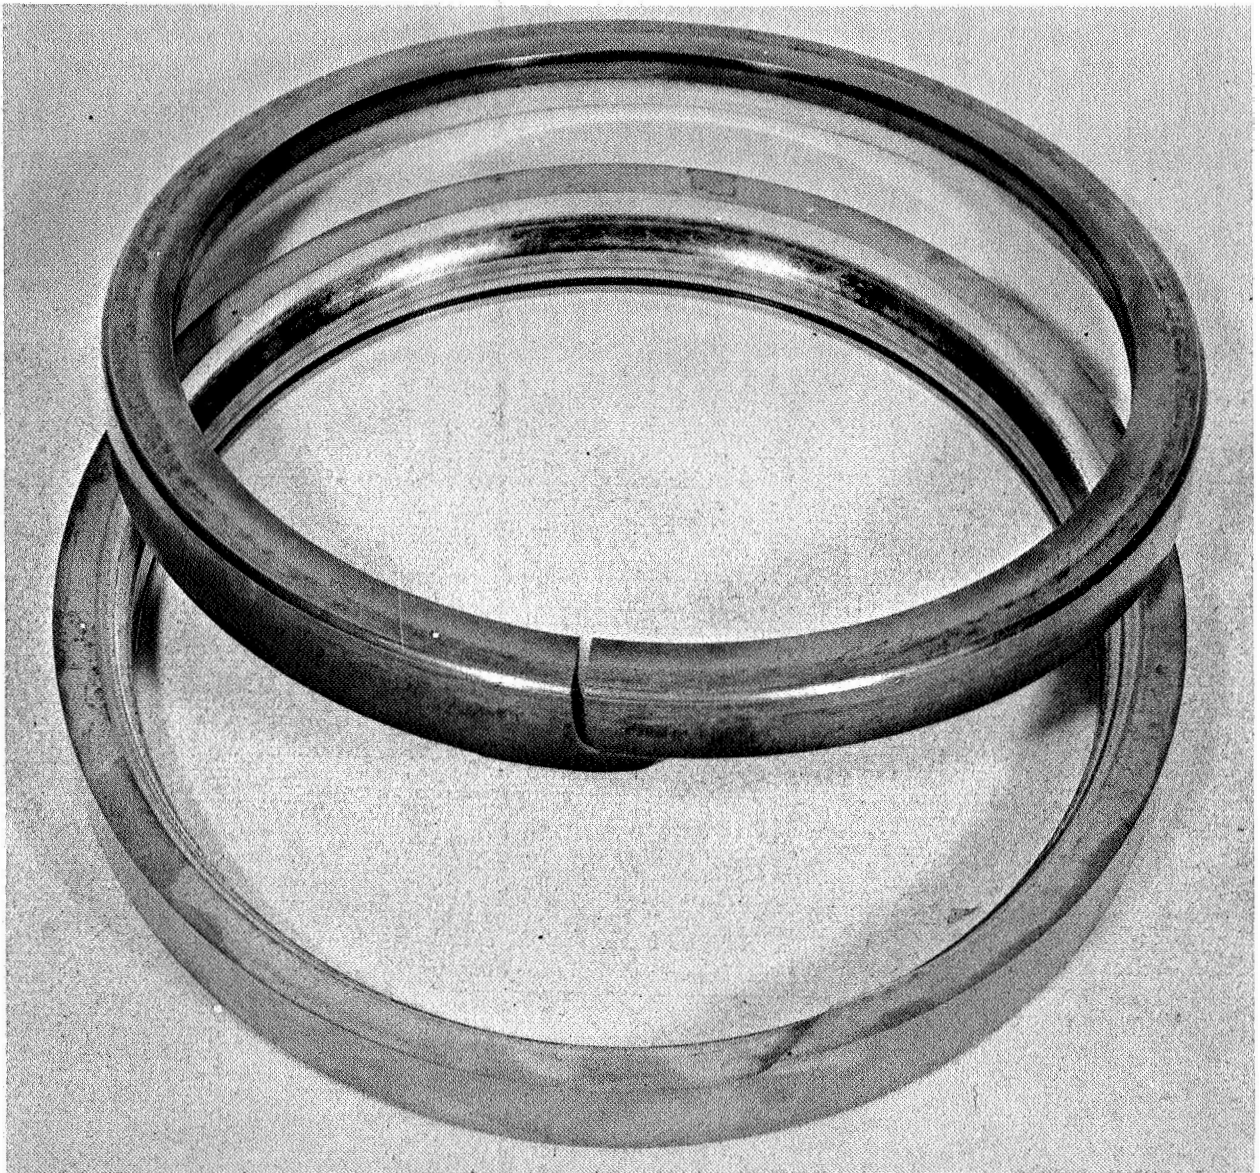
FIGURE 107. BEARING S/N 272.

CLOSE-UP OF CIRCUMFERENTIAL OUTER  
RING FRACTURE AFTER 13 HOURS.

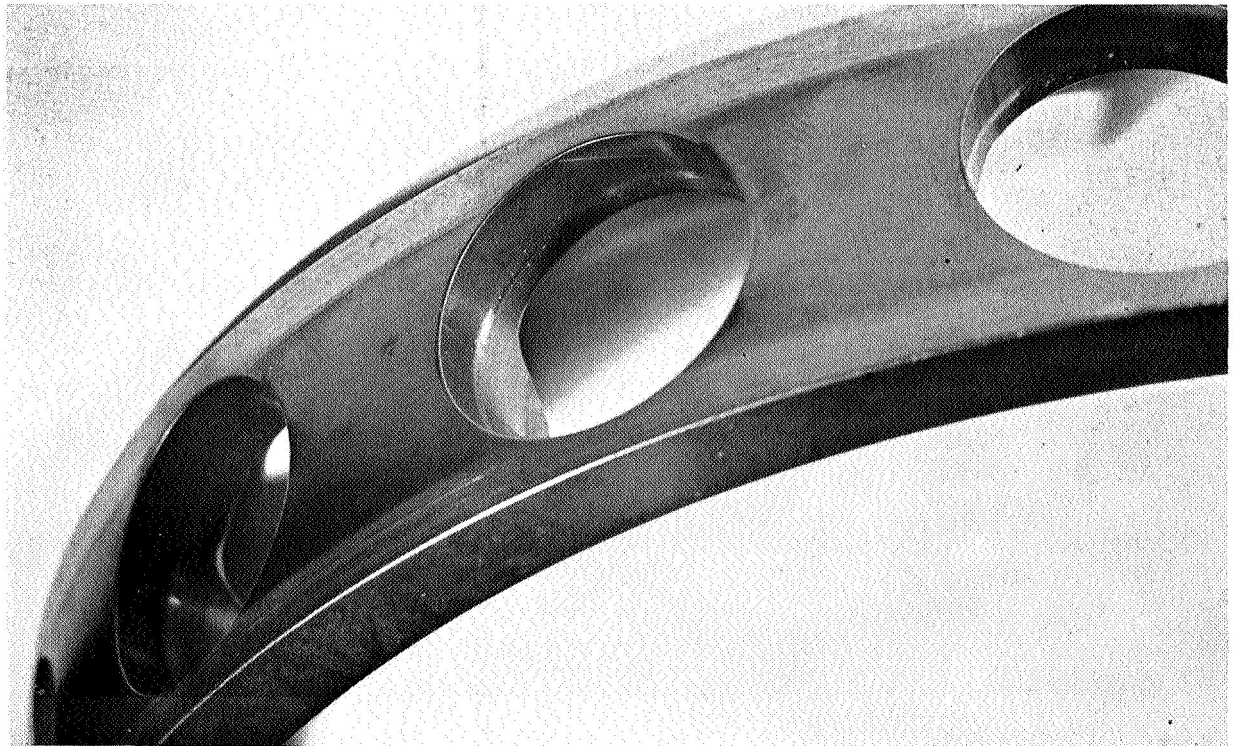
FIGURE 112. BEARING S/N 172.

APPEARANCE OF BALLS **AND** RETAINER  
AFTER 767 HOURS AT 400F WITH XRM-177F.

The photographs in Figures 111 through 113 illustrate the typical condition of the M-50 bearings after prolonged operation at 400F in nitrogen inerted XRM-177F. As can be seen from the photographs, the bearing components are in excellent condition. Of particular interest is the fact that several of the bearings in this test series including the one shown in the referenced photographs had been given a black oxide coating (Dulitizing) in order to more sharply define the ball track and thus the operating contact angle. The oxide coating apparently had no effect on the bearing life, although it did serve to accurately delineate the ball path as is illustrated in Figure 113,

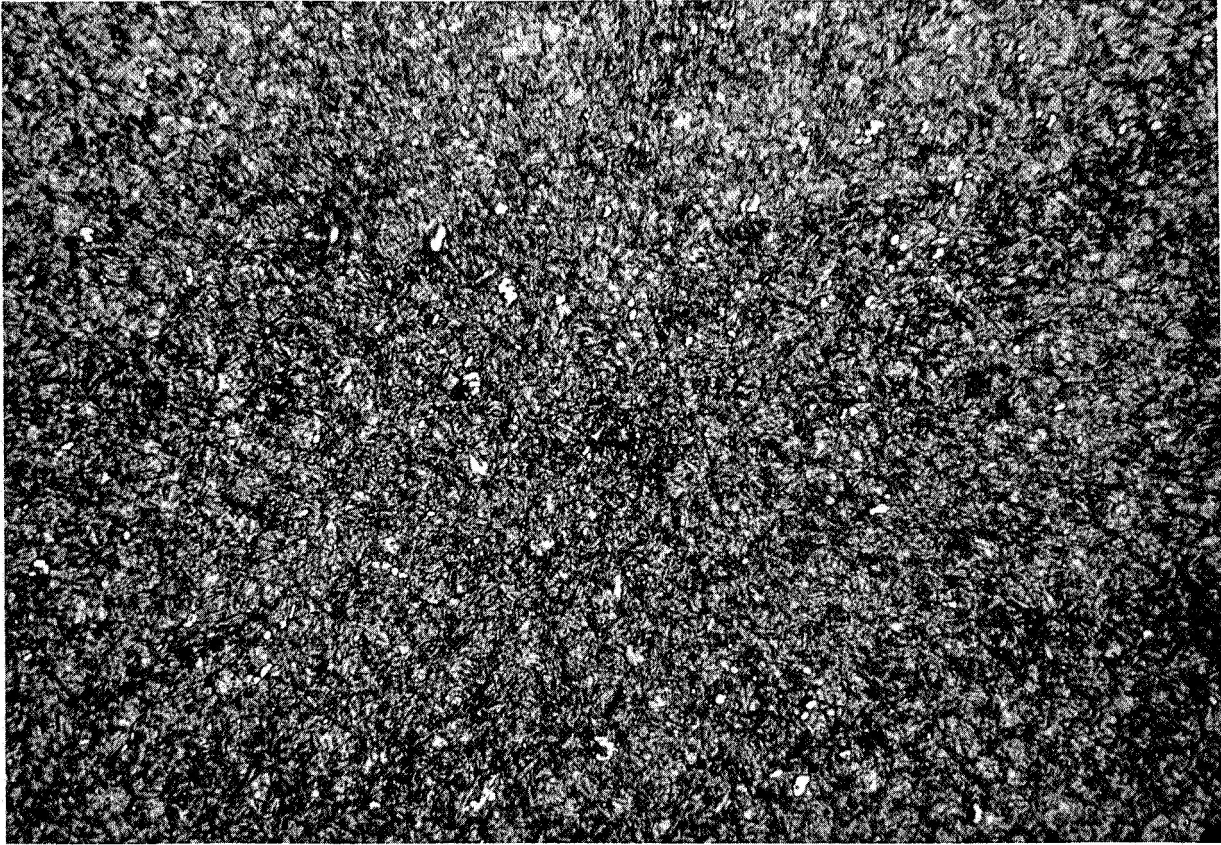
FIGURE 118. BEARING S/N 21

30.3 HOURS @ 5800 LB. @ 600F  
LUBRICANT: XRM-177F  
BALL WEAR  
MATERIAL: CVM-M-50  
MAG: 500X UNETCHED
